Advancing Post-Mining Waste Dump Safety and Sustainability  
Grant Agreement Project No 101157379 — MiDSafe

## **Work Package 2**

### ***Deliverable related No D2.1.***

Report on archival data, designs, past failures, guidelines and regulations on mining dumps and in- situ surveys of chosen dumps

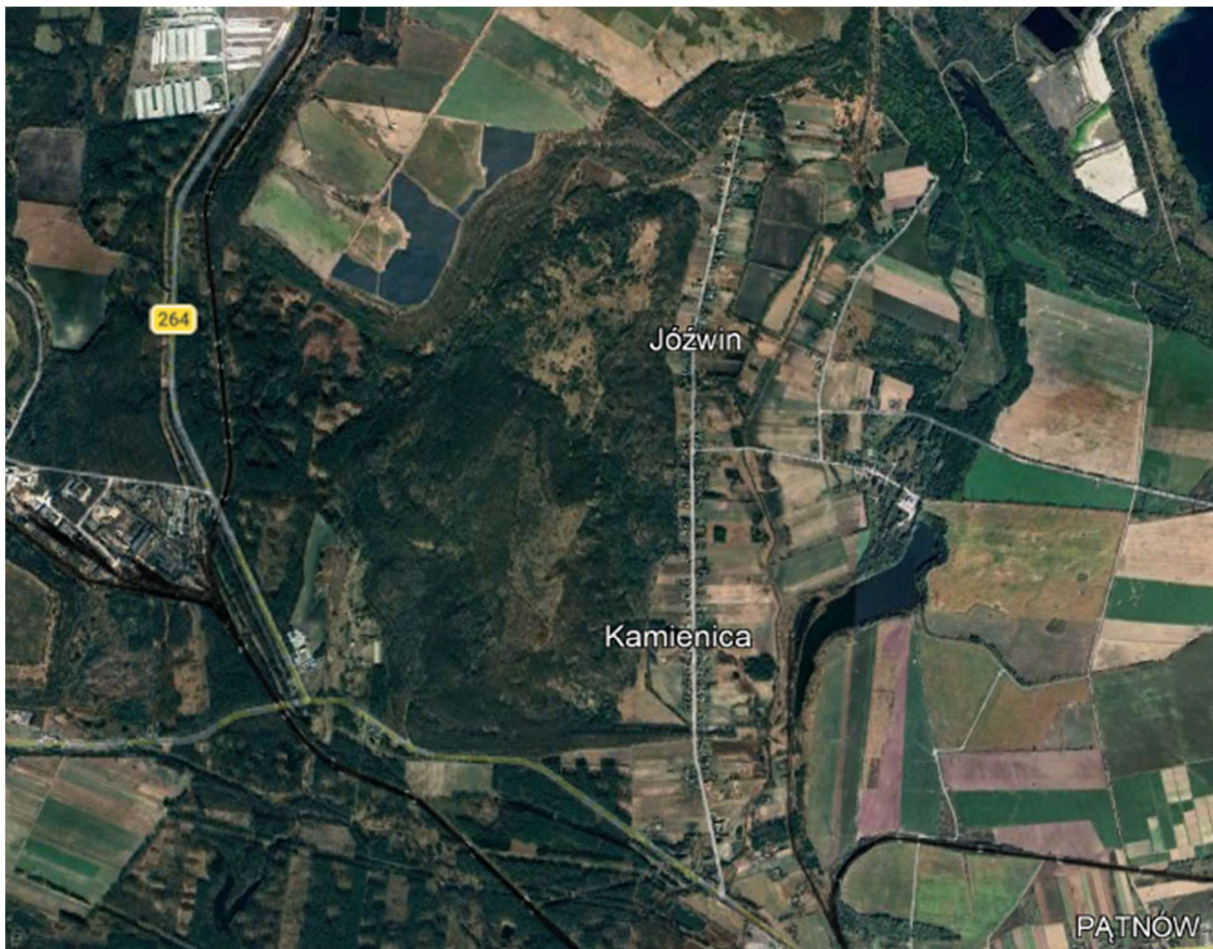
Fig. 2 Józwin external dump (Google Earth)

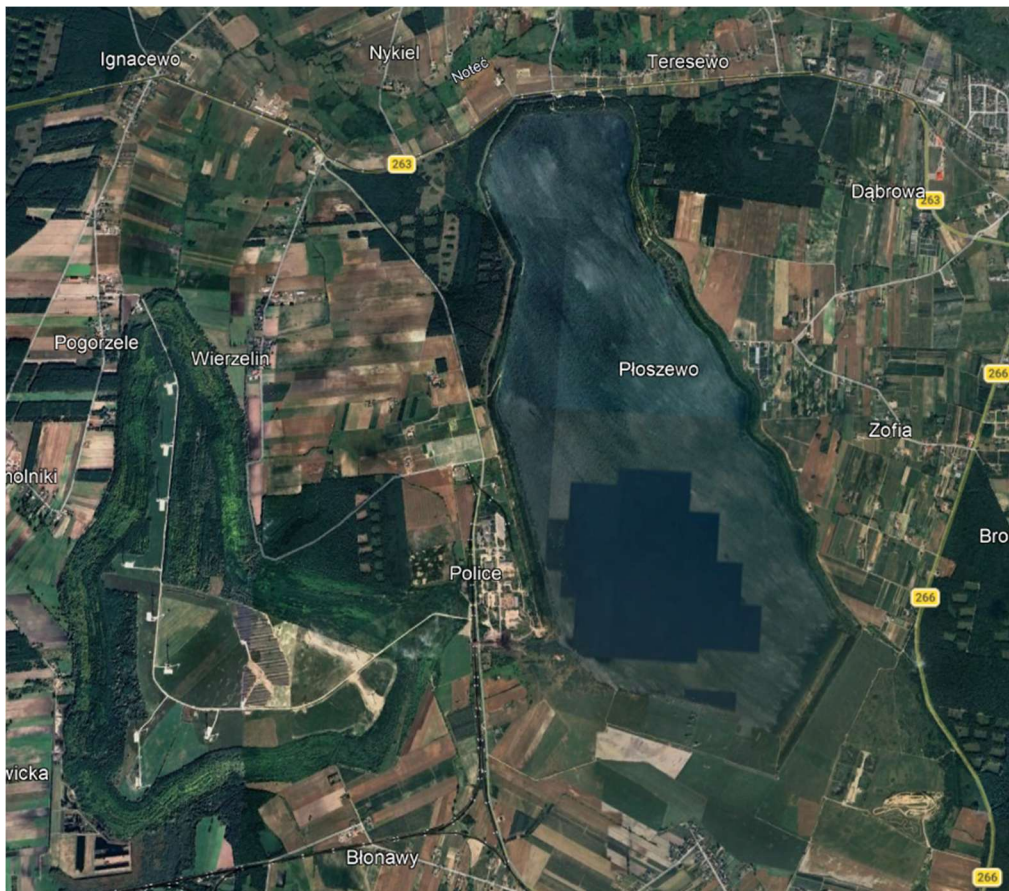
Fig. 5 Lubstów pit lake and external dump (Google Earth)

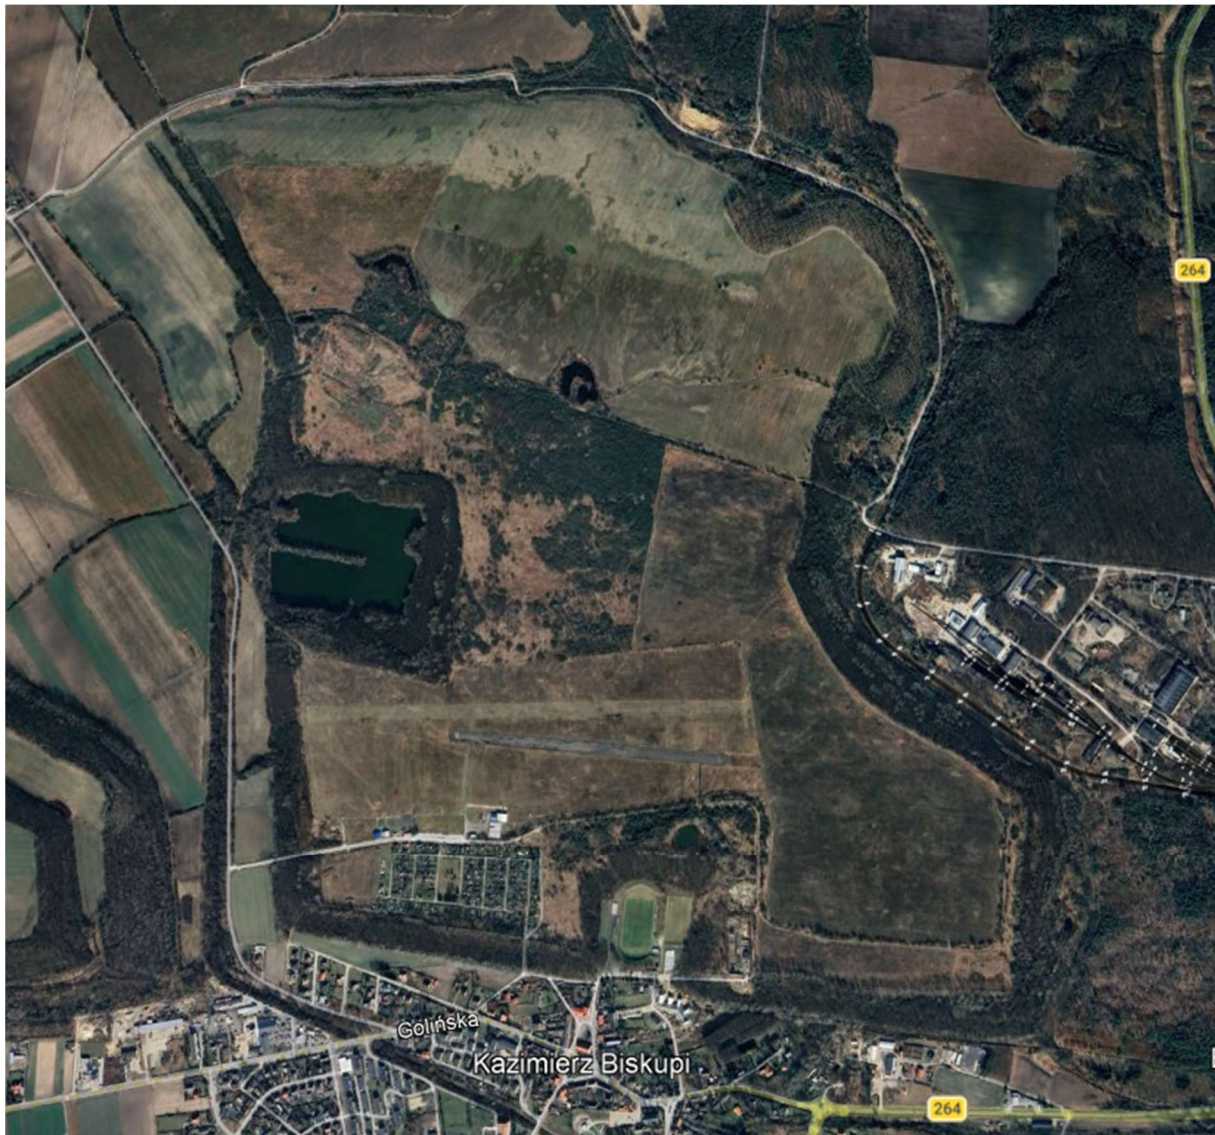
*Fig. 7 Kazimierz external dump (Google Earth)*

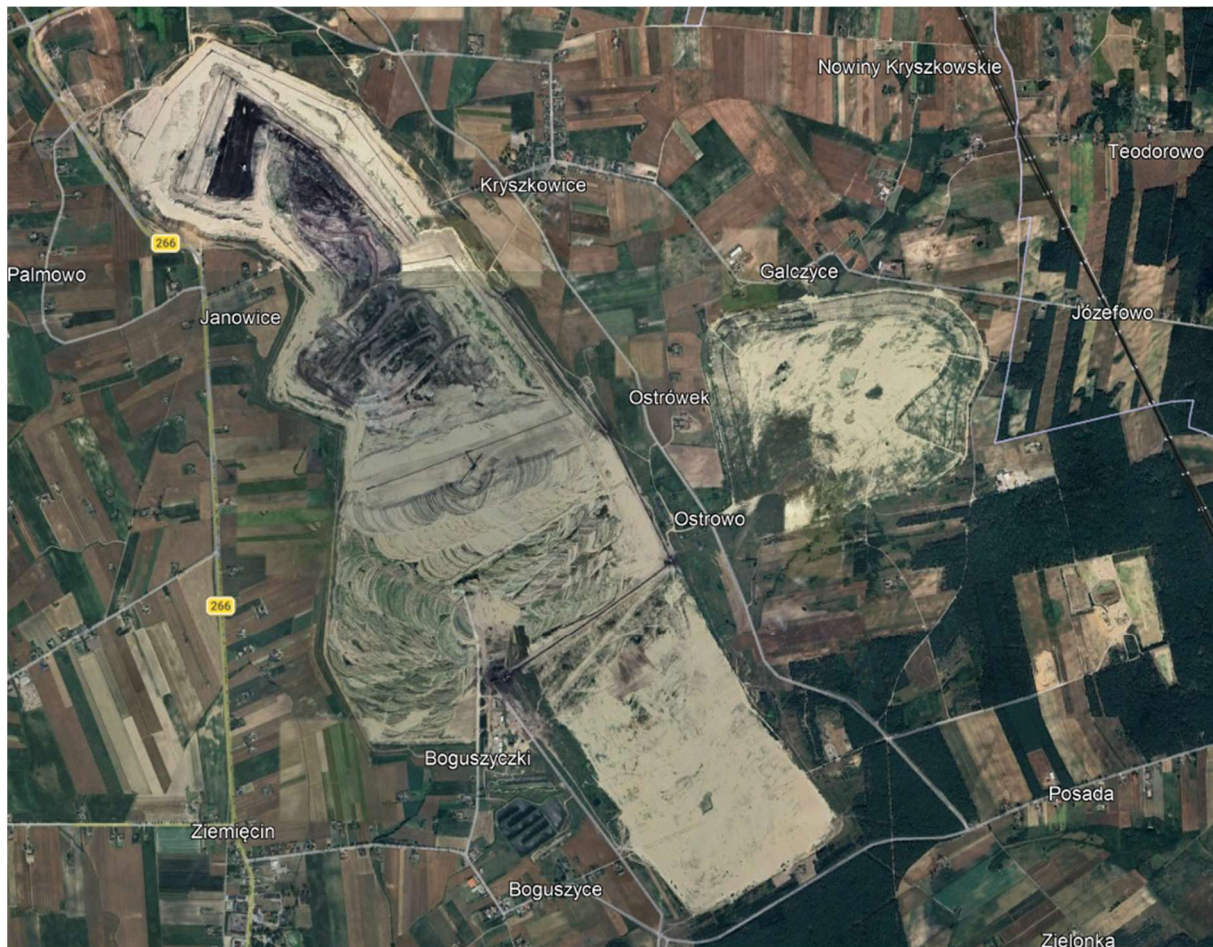
Fig. 9 Tomisławice open pit and external dump (Google Earth)

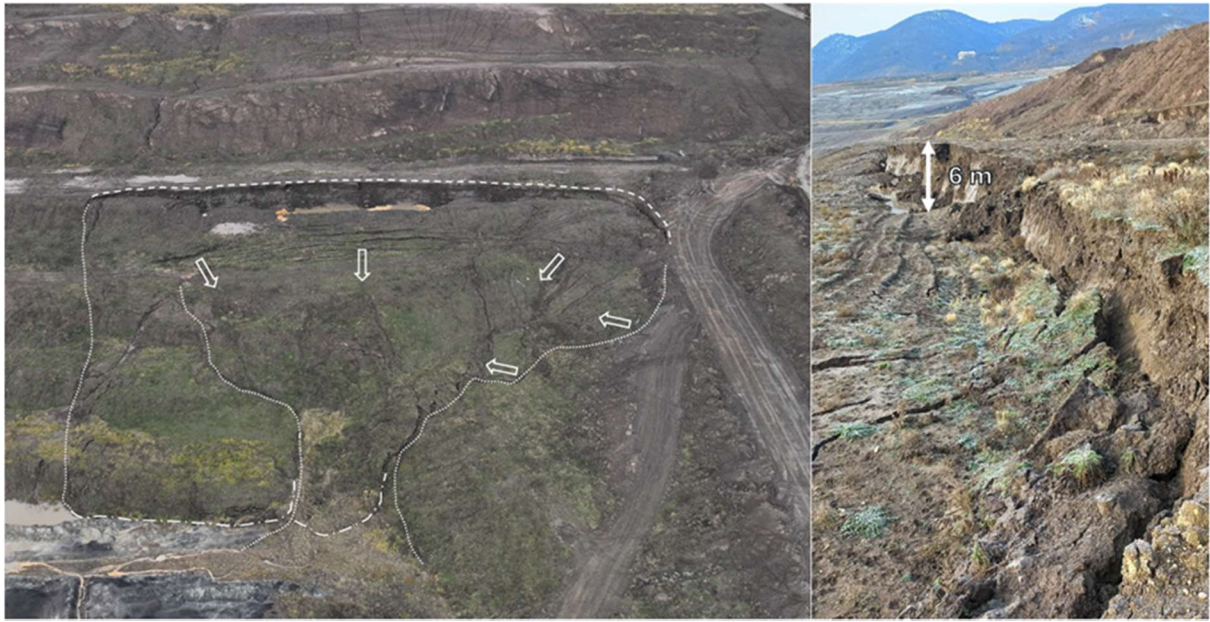
A frontal landslide measuring approximately 190 m in width and 140 m in length was detected (Fig. 17), with a main scarp approximately 6 m high. The total volume of landslide material is approximately 12,000 m<sup>3</sup>. Based on a digital terrain model, it is possible to interpret the probable direction of movement of the material, identify the causes, and propose appropriate remediation measures. Thanks to the high operability of UAVs, it is possible to continuously monitor whether further deformations are occurring outside the existing contour of the landslide. The use of UAVs also shows its advantages in winter, when access to the site is significantly limited by adverse terrain conditions.

*Fig. 17 Frontal landslide recorded during the last UAV monitoring campaign*

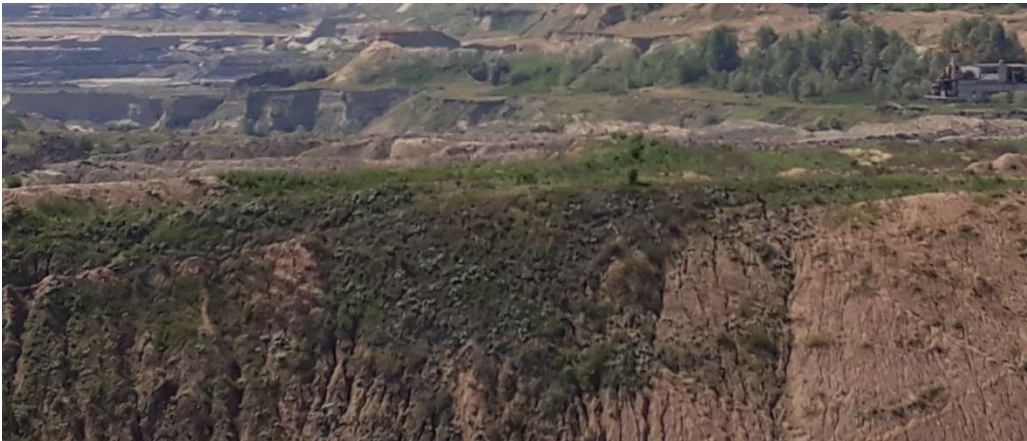
- On slopes with an inclination greater than 30°, gullies and ravines (Fig. 20), formed as a result of the superficial runoff of precipitation, can be observed. In the absence of measures to stop these phenomena, over time, they will act as factors favoring the triggering of landslides;

*Fig. 20 Erosion phenomena*

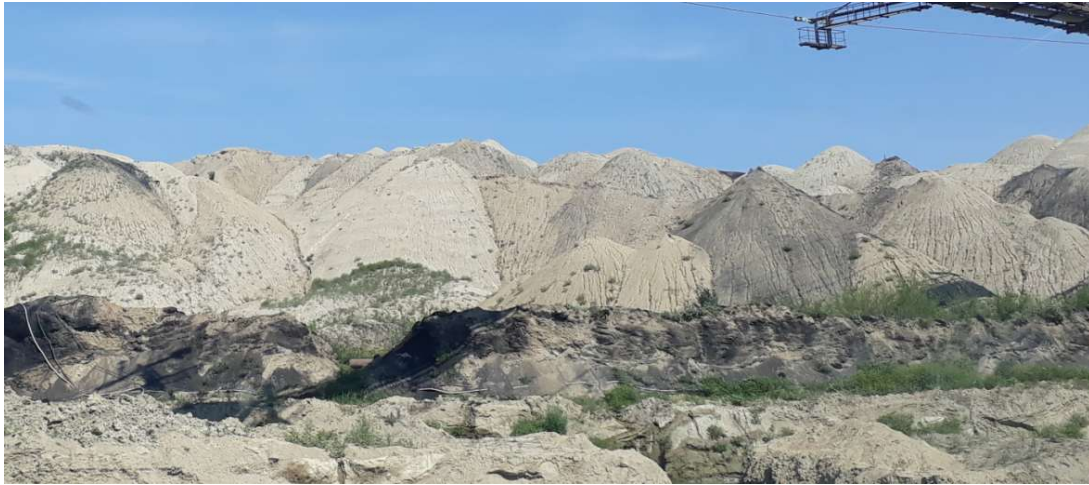
- In previous years, when, on the contrary, there were periods of excess precipitation, relatively small areas were observed where swelling phenomena occurred (both of the rocks in the foundation of the dumps and of the dumped rocks). This phenomenon is also due to the presence of clays, which have a high-water storage capacity, and by increasing in volume can lead to the destabilization of the dumps.
- Another important observation is that the tailings deposit in the advancing stage is not done uniformly (Fig. 22), this aspect favoring the accumulation of precipitation water at the base of the dump and its subsequent infiltration into the body of the dump, thus increasing the risk of landslides;

*Fig. 22 Uneven depositions*

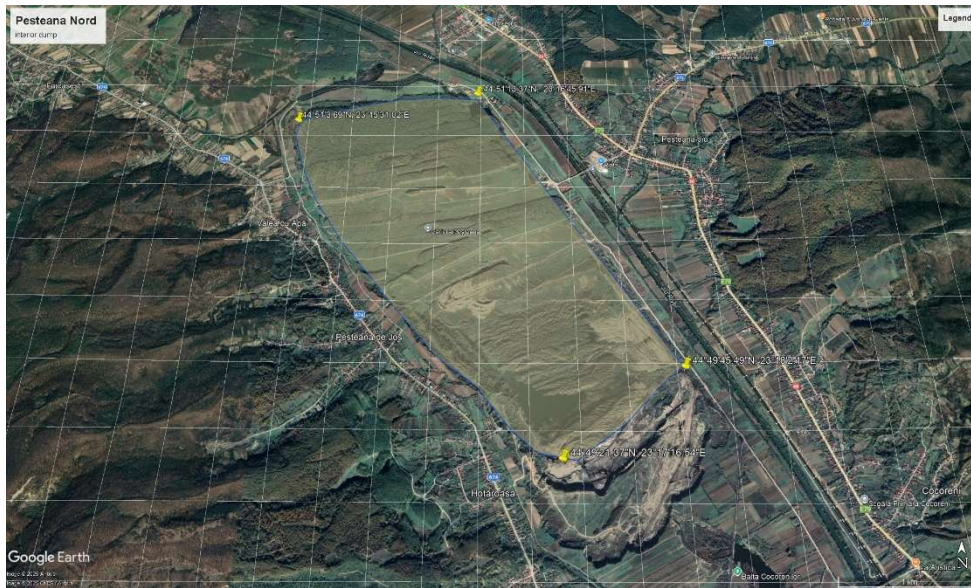
The sterile rocks from the Peșteana Nord open pit are dumped in the interior dump of the same name, using 3 dumping machines (Fig. 23).

Fig. 23 Peșteana Nord open pit and interior dump (Google Earth Pro)

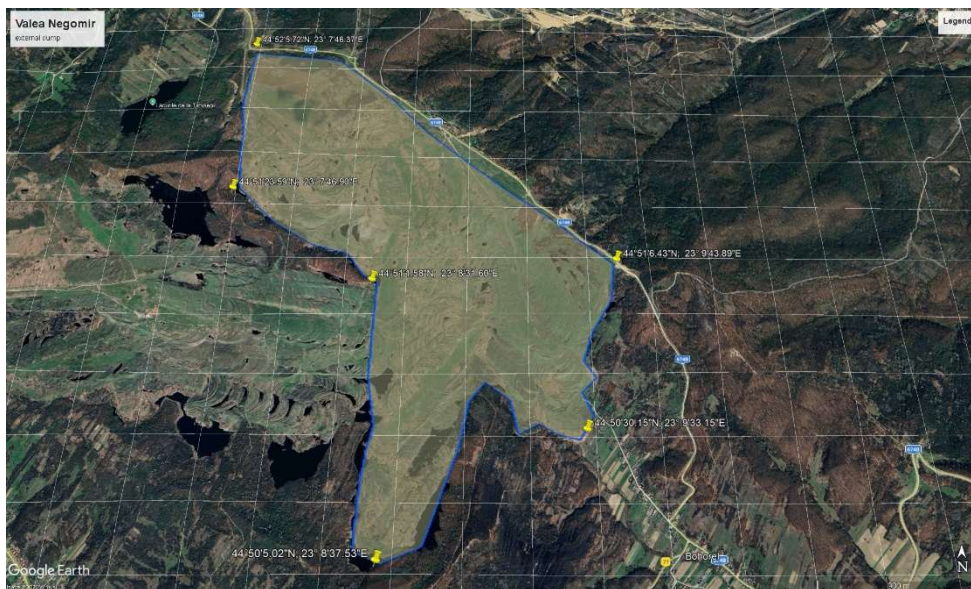
Valea Negomir dump was designed to store part of the waste rocks from the Pinoasa open pit. It is located in the Negomir Valley, south of the Pinoasa open pit (Fig. 24).

*Fig. 24 Valea Negomir waste dump (Google Earth Pro)*

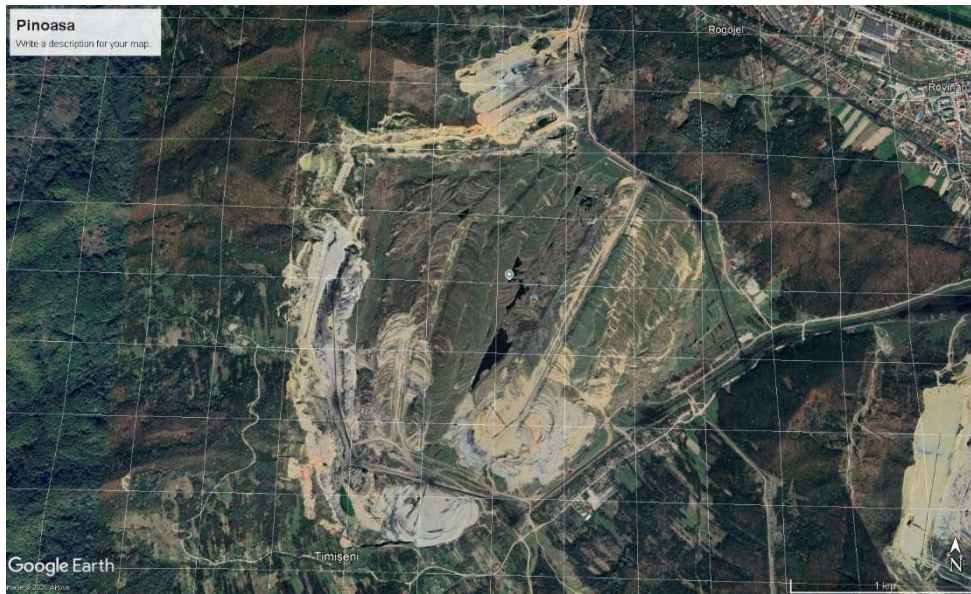
Pinoasa interior waste dump was also designed to store part of the waste rocks from the Pinoasa open pit (Fig. 25).

*Fig. 25 Pinoasa open pit and internal waste dump (Google Earth Pro)*

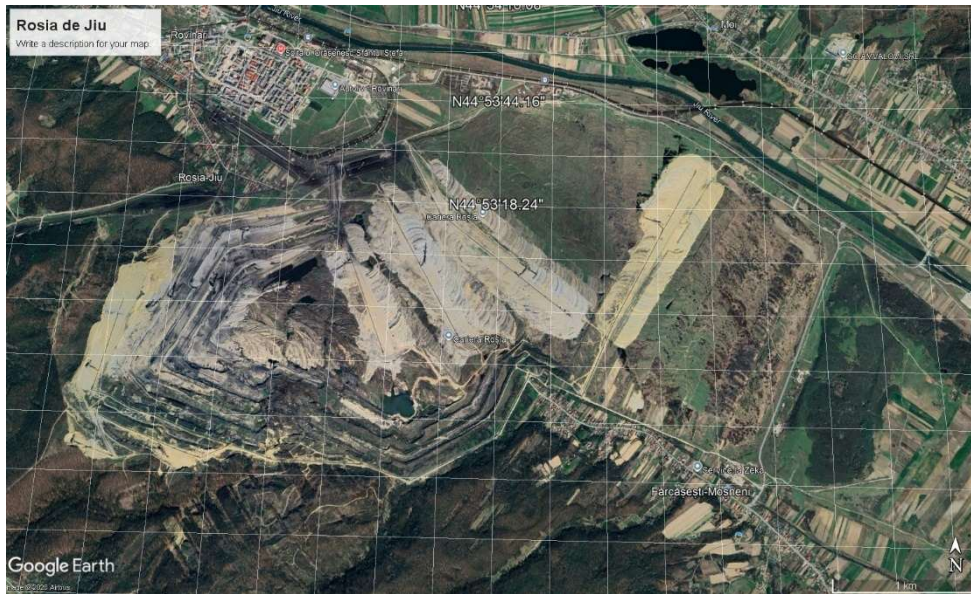
Roşia de Jiu interior dump is located south of the opening trench of the Roşia de Jiu open pit and consists of 10 steps, the deposition in the exterior dump having long been completed (Fig. 26).

*Fig. 26 Roşia de Jiu open pit and internal waste dump (Google Earth Pro)*

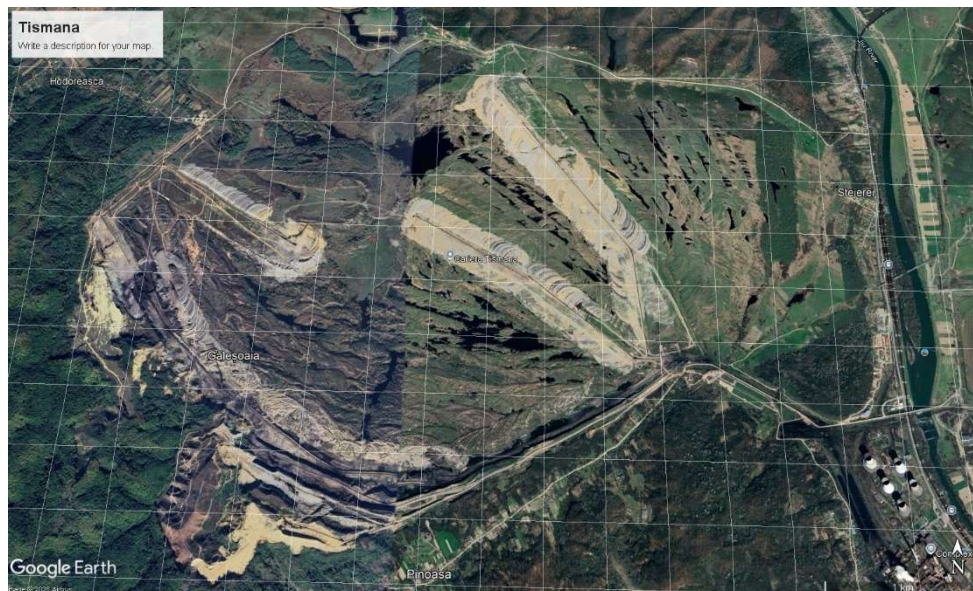
Although in some documentation these are still addressed separately, in reality they are united, which is why they will be treated as such (Fig. 27).

*Fig. 27 Tismana open pit and internal waste dump (Google Earth Pro)*
